IMPORTANT PRODUCT INFORMATION

Product: IC693CPU364 CPU Module with Ethernet Interface
IC693CPU364-EK with CPU Firmware Version 10.71

This release consists of a hardware update on the Ethernet daughterboard.

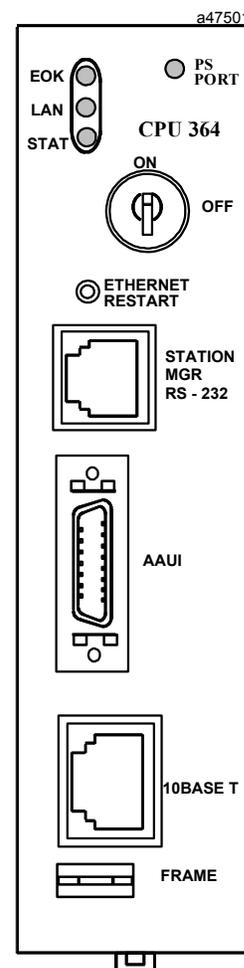
Notes: On earlier modules, the LED labeled "PS PORT" may read "SNP," and/or the port labeled "STATION MGR RS-232" may read "PORT 1 RS-232"; these are labeling changes only - the functionality was not changed.
