# PACSystems\* RX3i

IC695CPU320-HY

## PACSystems\* RX3i CPU

GFK-2488AB  
June 2015

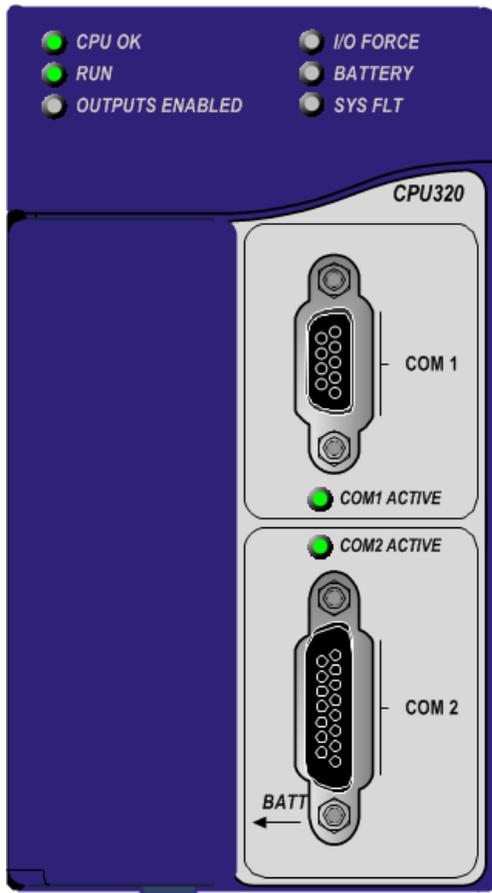
The PACSystems\* RX3i CPU can be used to perform real time control of machines, processes, and material handling systems. The CPU communicates with the programmer and HMI devices via a serial port using SNP Slave protocol. It communicates with I/O and smart option modules over a dual backplane bus that provides:

- High-speed PCI backplane for fast throughput of new advanced I/O.
- Serial backplane for easy migration of existing Series 90\*-30 I/O.
